SUBJECT Photographs of Riga and Ventspils and Vessels Sighted in These Ports

Russian Warships at VENTSPILS.

Russian Warships at RIGA.

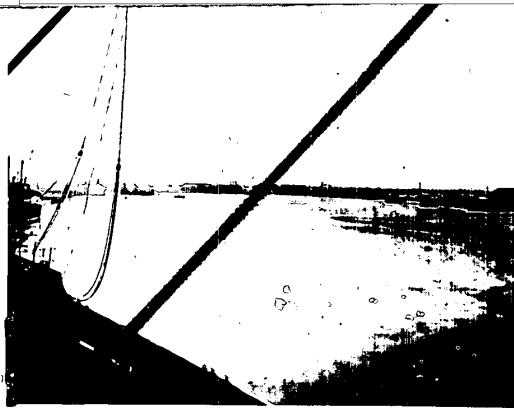
1. Photographs numbers 1 and 2 [redacted]
[redacted] show an oiler at which small naval craft
were seen to oil.

35MN USSR LATVIAN SSR VENTSPILS
57 24 N 21 31 E OILER IN PORT AREA
FOR REFUELING SMALL NAVAL SHIPS

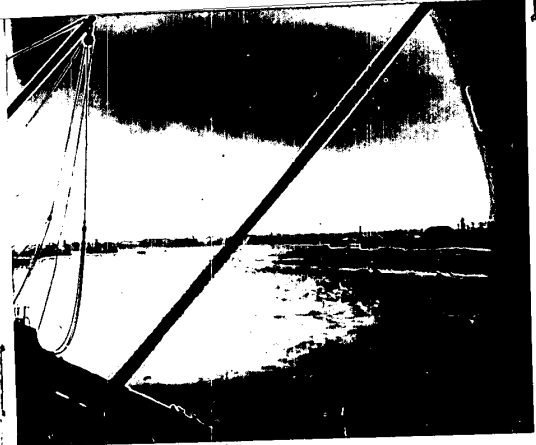
35MN USSR LATVIAN SSR VENTSPILS
57 24 N 21 31 E OILER IN PORT
AREA FOR REFUELING SMALL NAVAL

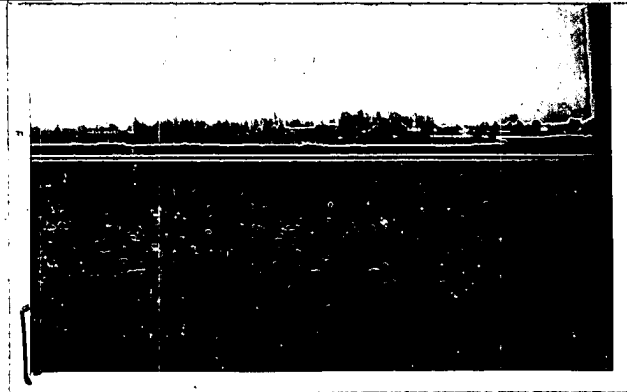
Photographs 5 - 7, 8 and 9 are panoramic views of the approaches
to RIGA [] and show one Bird
class Russian destroyer berthed in the inner harbour and a number of
Motor Torpedo Boats on the beach.

35MN USSR LATVIAN SSR RIGA 56 57 N
24 09 E ENTRANCE TO DVINA RIVER.
BIRD CLASS DESTROYER IN INNER HARBOR.
MOTOR TORPEDO BOATS ON BEACH. PART 3
OF 3-PART PANORAMA.

35MN USSR LATVIAN SSR RIGA 56 57 N
24 09 E ENTRANCE TO DVINA RIVER.
PART 1 OF 3-PART PANORAMA.

35MN USSR LATVIAN SSR RIGA 56 57 N
24 09 E ENTRANCE TO DVINA RIVER.
BIRD CLASS DESTROYER IN INNER HARBOR.
MOTOR TORPEDO BOATS ON BEACH. PART 2
OF 3-PART PANORAMA.
